# **CH-47**

**CH-47 ACCIDENT SUMMARY**

1 July 1966 through 30 June 1967

# CH-47 Accident Summary

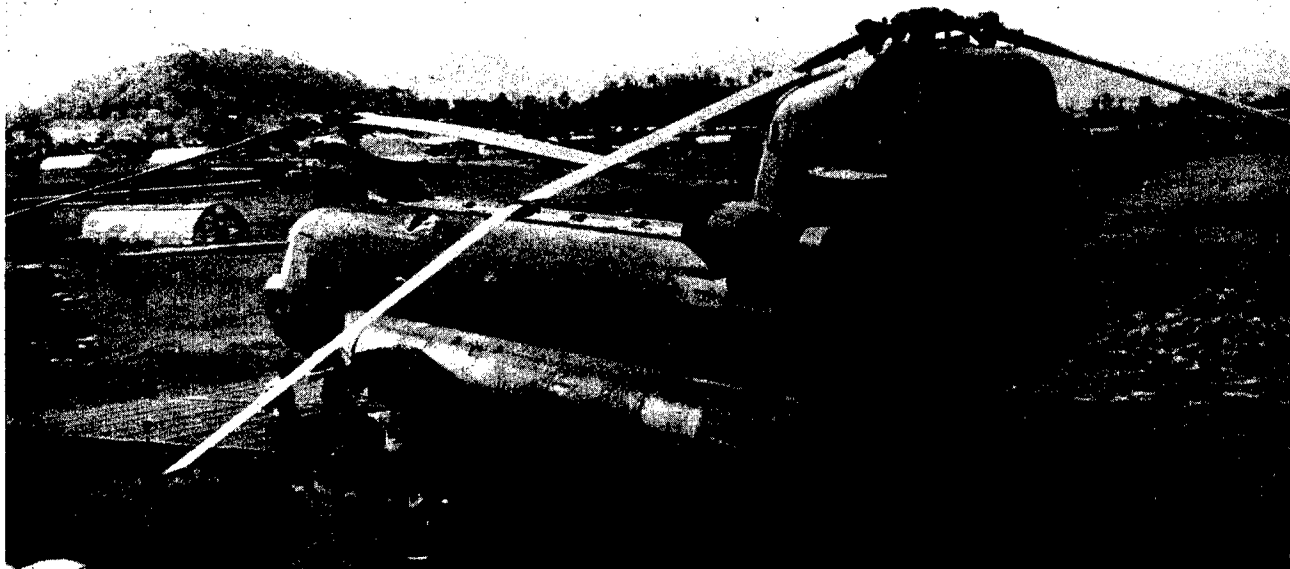
**011506**—Aircraft disintegrated in air. Six crew-

members and three passengers killed. Caused by fatigue failure of spar of one aft rotor blade at station 200.5.

011506-Fatigue failure of aft rotor blade spar caused aircraft to disintegrate during flight.
